Indian Head Division
Naval Surface Warfare Center
Indian Head, MD 20640-5035

IHTR 2158
22 January 1999

HAZARD DIVISION 1.2 TESTING IN A MINIATURE MAGAZINE

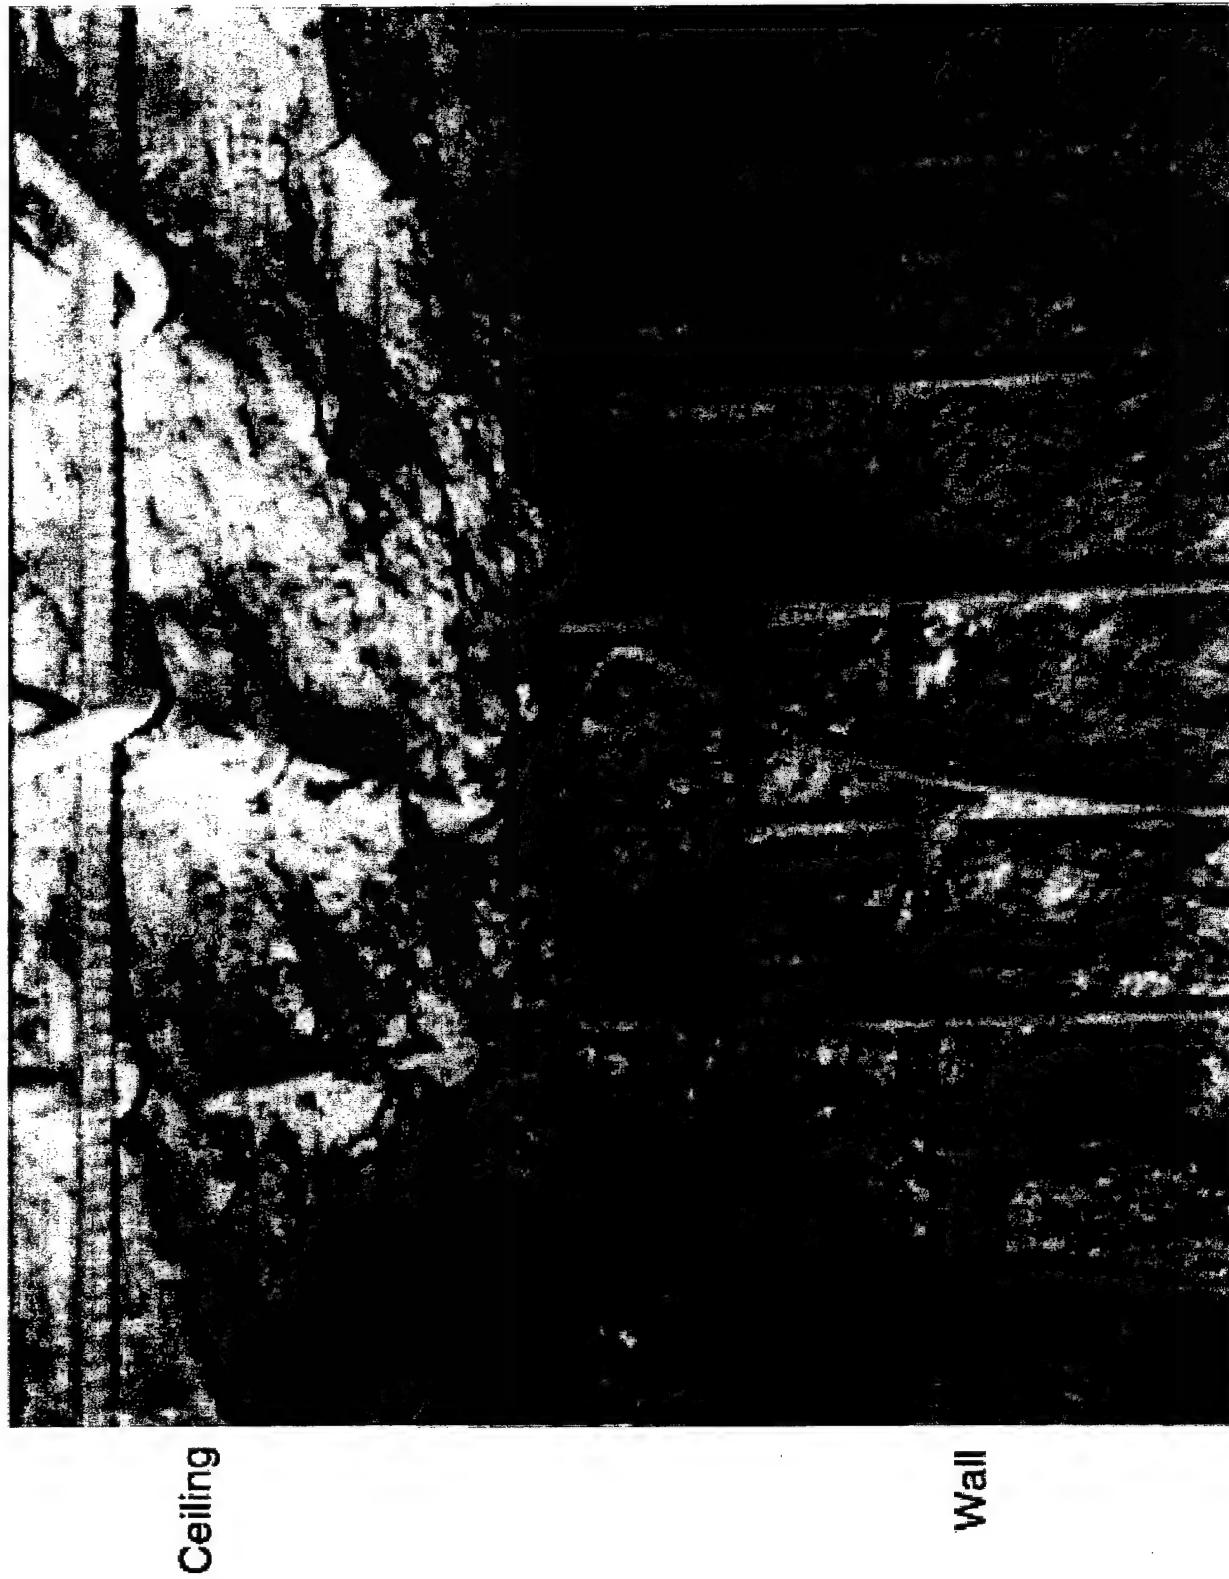
1) The calculated temperatures of the upper gas layer in the mini-magazine fire are shown in Figure 5. The upper gas layer was calculated by CFAST to extend down to about 2 feet above the floor, thus the roof and most of the walls were exposed to temperatures of 1400°F at the start of the fire and 1900°F at the end of the fire. The temperatures of the upper layer were applied as a convective and radiative boundary condition to the concrete surface to determine the temperature response. Figure 6 shows the temperature contours in a 3-D segment of the wall at the point of maximum heating at the end of the fire (60 minutes) when no erosion was assumed. In Figure 7, erosion (heat spalling) is assumed to occur when the concrete reached 1000°F. Here, the heat penetrates twice as far as in the no erosion case. In the erosion case, the model simulates erosion by changing the conductivity and specific heat of all nodes that attain 1000°F or more, thus effectively removing them from the calculation. By comparing the heat penetration of all nodes above 1000°F (considered removed) to the reinforcement bar pattern in Figure 2, it can be seen that the concrete surface is predicted to erode just past the vertical bar (about 4 inches from the original surface). Figure 8 shows a picture of the erosion damage to the walls and ceiling in the interior of the mini-magazine after the fire. The erosion can be seen to penetrate about 4 inches on the walls and ceiling.

Figure 8. Mini-Magazine Fire Erosion Damage.
